ANNUAL ENVIRONMENTAL AND SOCIAL COMPLIANCE AUDIT REPORT

52 MW Power Plant at Jangalia, Comilla

Lakdhanavi Bangla Power Limited

March, 2016

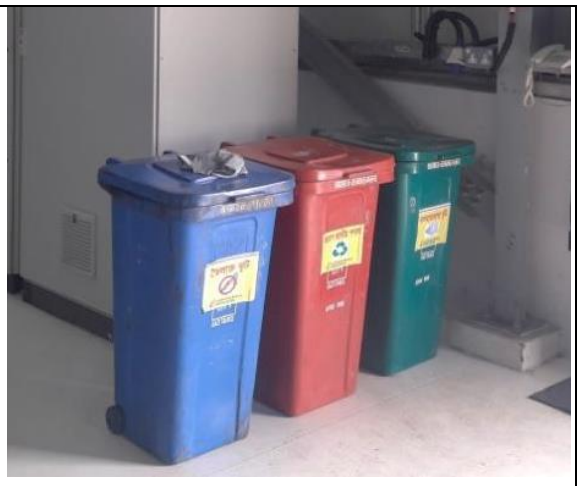
Photograph: Application of different types of dustbin

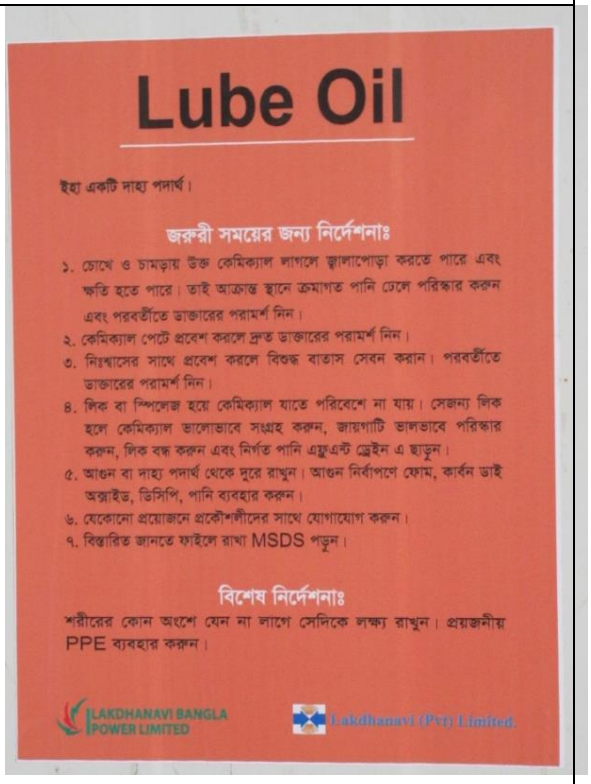
Photograph: Spill kit and lube oil management guidelines

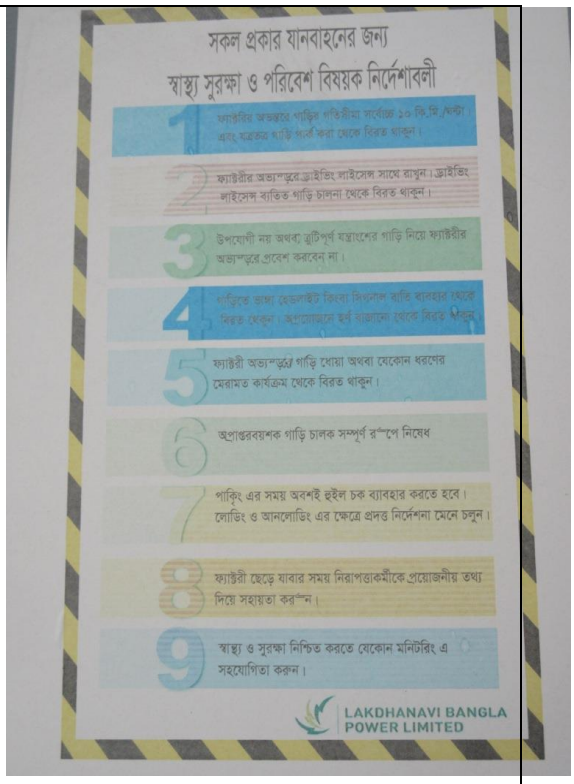
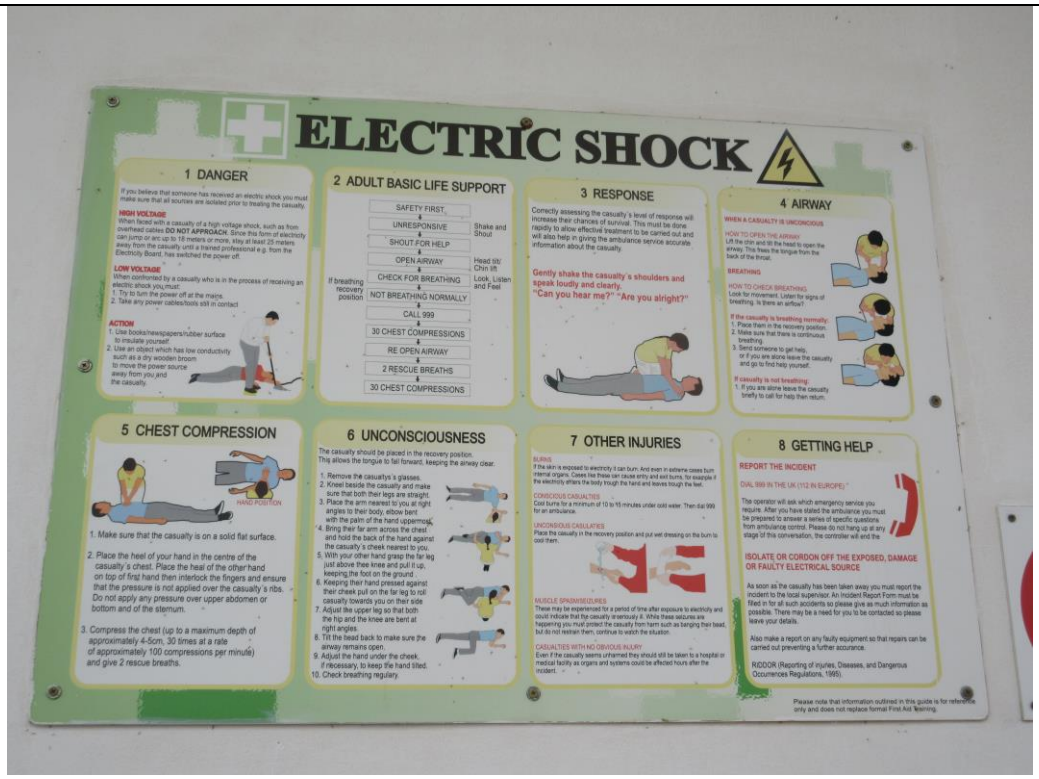
Photograph: Different types of safety signage

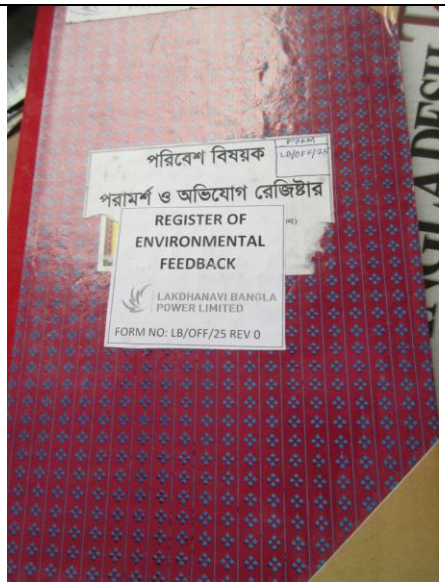
While audit, no record of grievances was being observed neither in the Grievance Log Book. In responding the issue of disclosure, LBPL has informed that they are adequately responsive to any stakeholders requesting to disclose any environmental, and social safeguards related document, information and monitoring result.

Photograph: Grievance Log Book
